Strategy for Urban Heritage Conservation in Depok City

Abstract

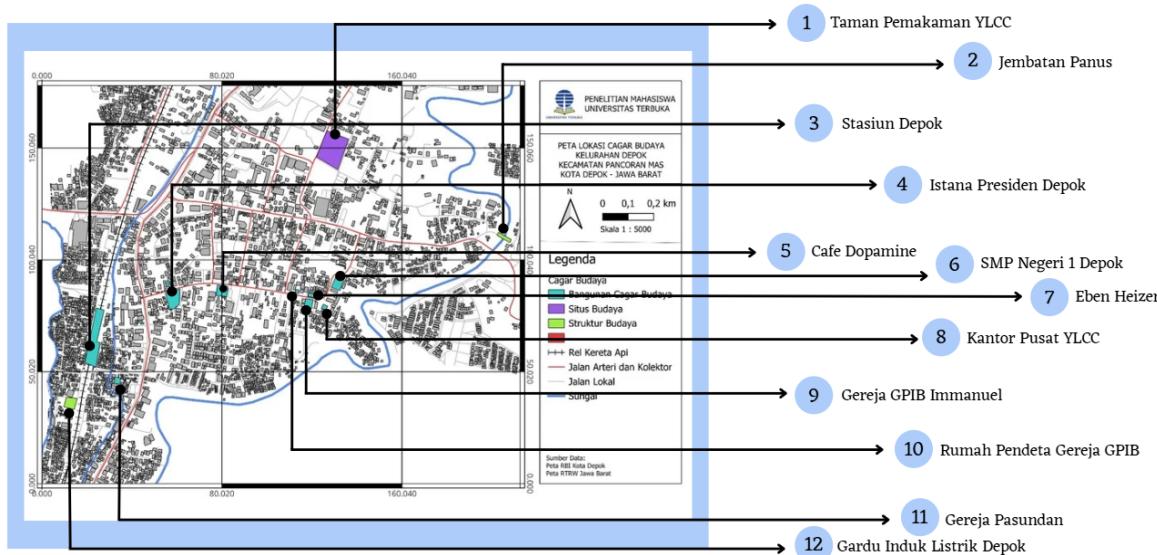
Figure 2. Map of the Distribution of Buildings/Cultural Heritage Sites in Old Depok

The Depok Lama area still has a strong Dutch influence, marked by buildings in the Indies style (Handinoto 1996, 213). Some of these Indies-style buildings have been designated as Cultural Heritage Sites. The designation of cultural heritage buildings requires special handling and is of significant historical value. The collection of buildings and cultural heritage sites in close proximity to one another makes this area a cultural heritage site. According to Wibowo (2014), cultural heritage objects are relics from certain communities that have important value because they can indicate the level of civilisation. Therefore, they need to be preserved so that their existence can be passed on to future generations.

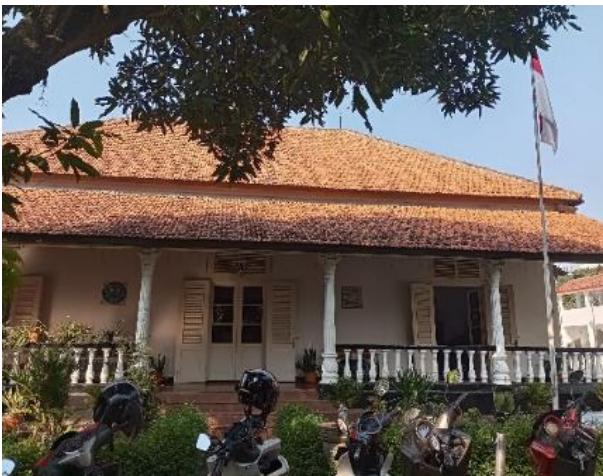
<p>The office of Yayasan Cornelis Chastelein (YLCC)</p>	<p>Dopamine Cafe</p>

From a technical perspective, several buildings, such as the YLCC Building and the GPIB Immanuel Church, have met safety, comfort, and accessibility standards. However, objects such as the Harapan Hospital and the Telephone Pole have not fully met technical requirements, particularly in terms of safety. This indicates the need for more targeted and sustainable conservation interventions. Functional adaptation is one strategy that has been successfully implemented in several buildings, such as Cafe Dopamine and the Post Office. These buildings have successfully adapted to contemporary needs without sacrificing their historical value. This approach demonstrates the economic and social potential of preserving cultural heritage buildings.

Next, the good category is represented by buildings with scores between 21 and 22 points, such as the YLCC Building (22 points), Café Dopamine/Former Pancoran Mas Elementary School (22 points), Pasundan Church/Former Depok Seminary (21 points), and the Eben Haezer Building (21 points). All of them have fulfilled the administrative aspects (3 points) well, but there are still variations in the technical aspects. The building layout generally has a value of 2, indicating that the function, layout, and architecture still need improvement. Reliability achieved a high score of 4 to 5, showing that the condition of the structure and utilities is still solid. Safety scored 2–3, meaning that basic standards are in place, but fire protection and risk mitigation are not yet optimal. The health aspect scored an average of 2, indicating that ventilation and sanitation are available but not yet optimal. Comfort is relatively high, ranging from 3 to 4, indicating that the quality of the space is quite good. Accessibility is only 1, confirming limited accessibility. In the preservation category, the scores for existence and importance are 1 each, indicating that formal recognition exists but documentation and preservation strategies still need to be strengthened.
